The Upper Yampa River Watershed Group

State of the Watershed Report

2014 State of the Watershed Report

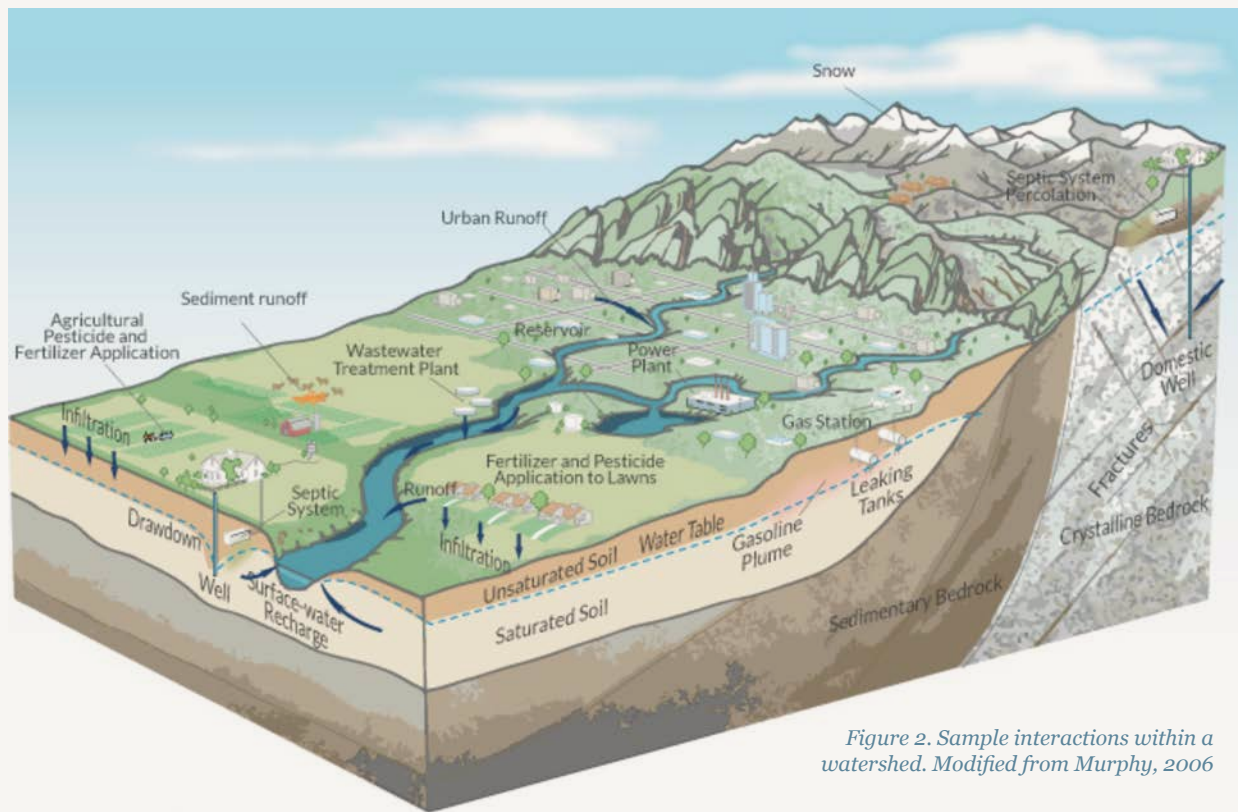
Figure 2. Sample interactions within a watershed. Modified from Murphy, 2006

A watershed is an area of land from which all water drains to a common point (Figure 2). Smaller subbasins make up a larger watershed and, in most cases, water eventually flows to the ocean. John Wesley Powell, scientist and geographer, said that a watershed is “that area of land, a bounded hydrologic system, within which all living things are inextricably linked by their common water course and where, as humans settled, simple logic demanded that they become part of a community.” Water on earth moves continuously through the hydrologic cycle: falling in the form of precipitation, running off or infiltrating the ground, and evaporating into the atmosphere where the cycle begins again. Surface water, such as streams and lakes, as well as groundwater, which is water stored underground are closely interconnected.

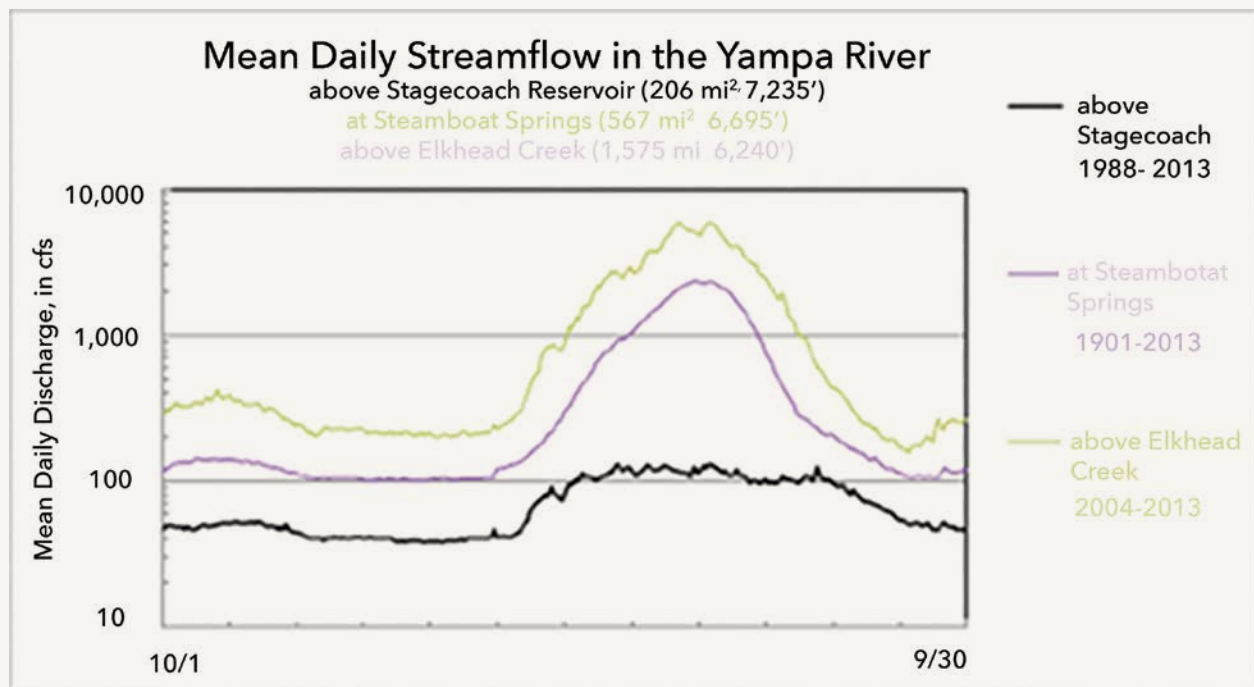
Figure 3. Mean daily stream flow in the Yampa River above Stagecoach Reservoir, at Steamboat Springs, and above Elkhead Creek. Baseline flows occur from late August through March before the peak snow melt driven run-off increases. Note the natural pattern of peak flows in the Yampa River above Stagecoach Reservoir is noticeably decreased by upstream storage of water in Stillwater Reservoir #1 and Yamcolo Reservoir. U.S. Geological Survey, 2014, National Water Information System data available on the World Wide Web (USGS Water Data for the Nation), accessed June, 2014, at URL <http://waterdata.usgs.gov/nwis/>.

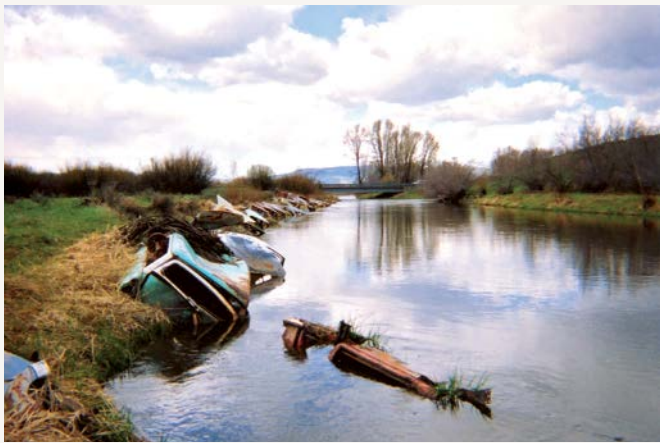
Figure 4. Before Restoration, Chuck Lewis State wildlife area spring 1999. Photo courtesy of BC Riverkeeper.

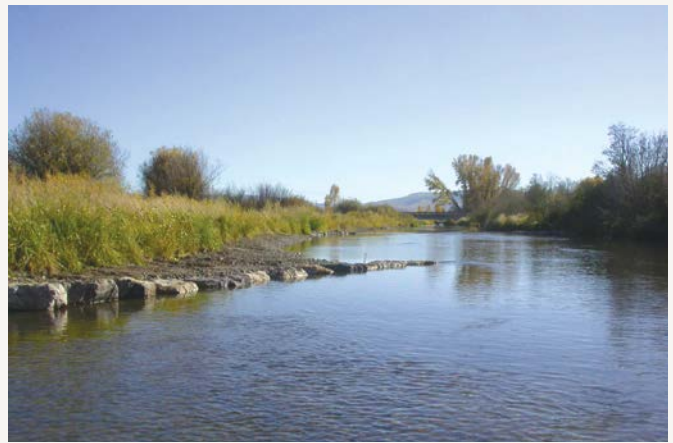
Figure 4. Restored riparian area, Chuck Lewis State wildlife area, spring 2003. Photo courtesy of BC Riverkeeper.

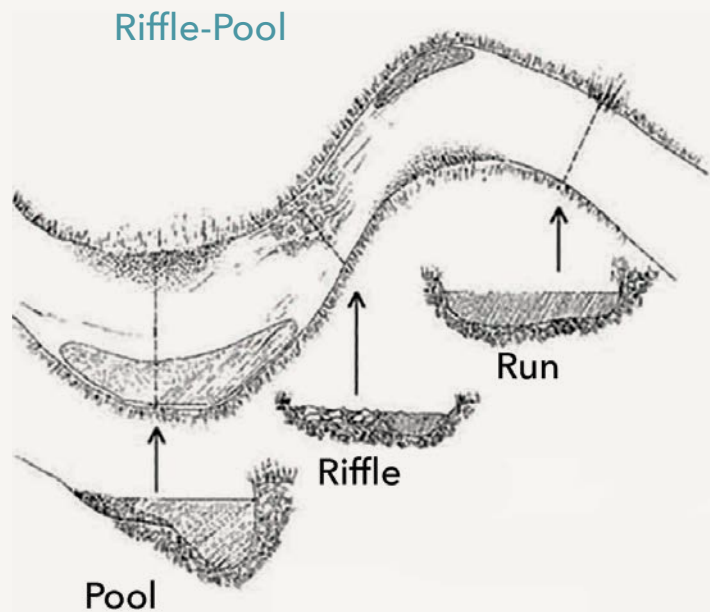
Figure 6. Riffle-pool system. Courtesy of the EPA.

Pool riffle ratios: A sequence of deep slow water sections (pools) and shallower faster moving water sections (riffles) develop at alternating, regularly spaced intervals. If a channel becomes overly wide, riffles will increase in length and alter the regular pool to riffle ratio. Riffles provide habitat for the macroinvertebrates that compose the basis of the food chain. Pools are important for dissipating energy and create habitat for aquatic organisms. Pools can be very important to survival of fishes in streams with seasonally high temperatures and low-flows (Figure 6).

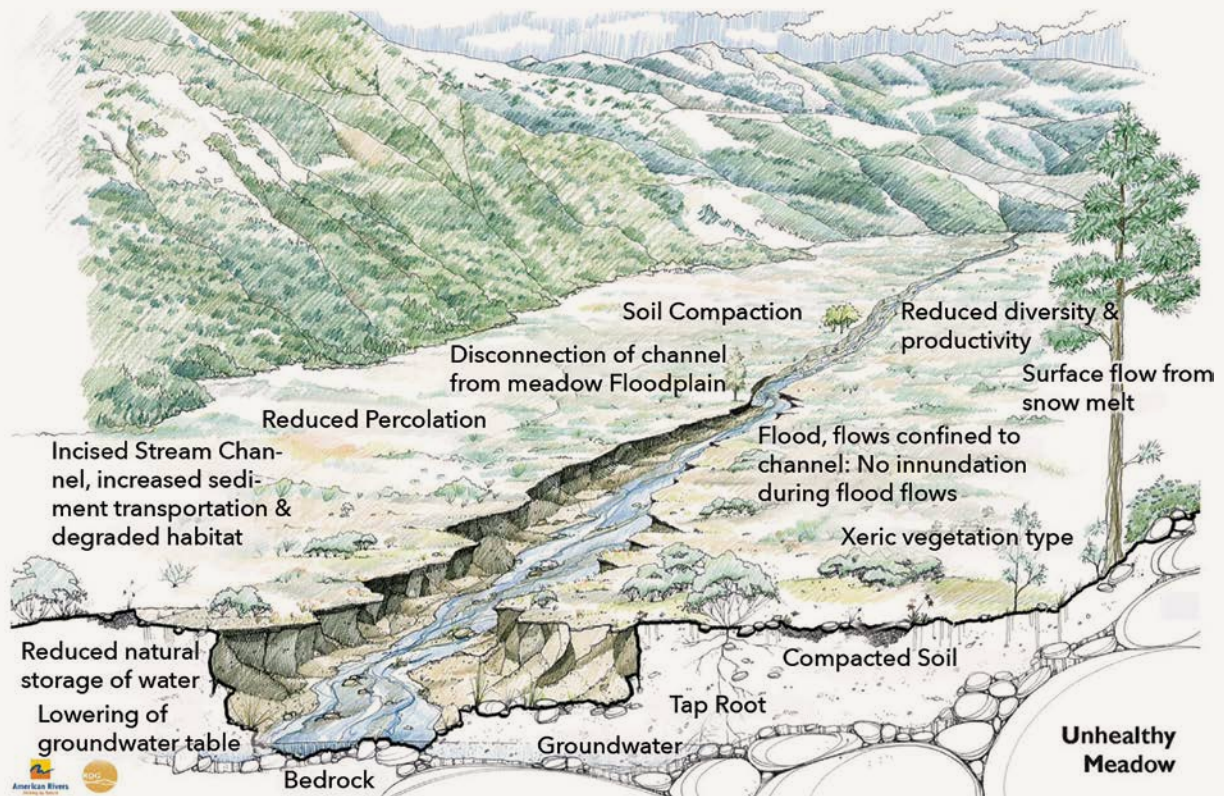
Figure 8. An unhealthy riparian zone. Courtesy of American Rivers.

Riparian zones are the transitional areas between uplands and streams, rivers, and lakes. These zones are inclusive of wetlands which are areas that undergo frequent flooding and support a range of vegetation adapted for life in saturated soils (Figures 7 and 8).

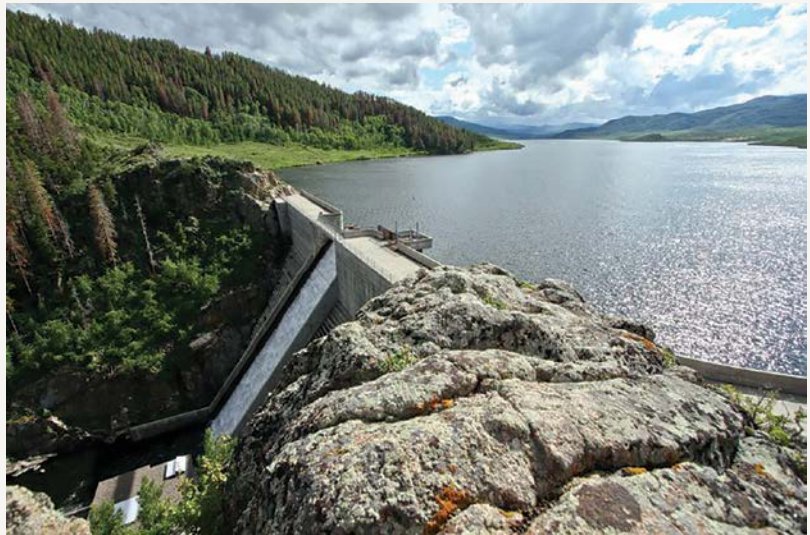
Figure 17. John Fetcher Hydroelectric Plant at Stagecoach Reservoir. Photo courtesy of Richard Stenzel

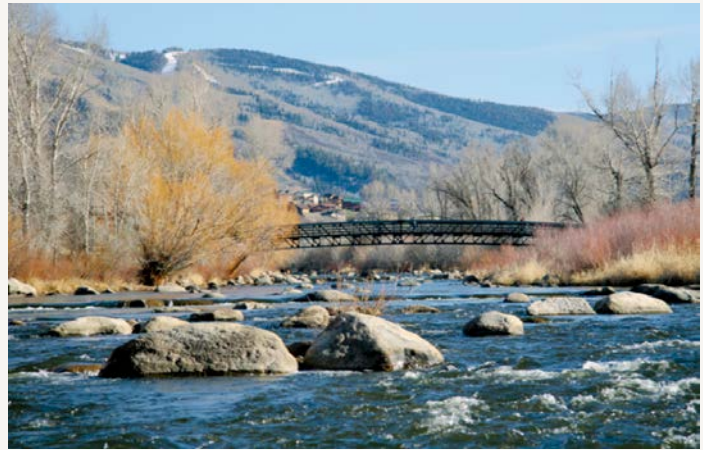
Figure 20. Yampa River in Steamboat Springs. Courtesy of Kent Vertrees.

Steamboat Springs has robust local and tourism-based recreation which largely depends on non-consumptive water uses including trout fishing, seasonal boating, and summer tubing. In 2005, the city was granted a Recreational In-Channel Diversion (RICD) from April 15 through August 15, which appropriated a minimum stream flow necessary for a reasonable recreational experience in and on the water (Figure 20).

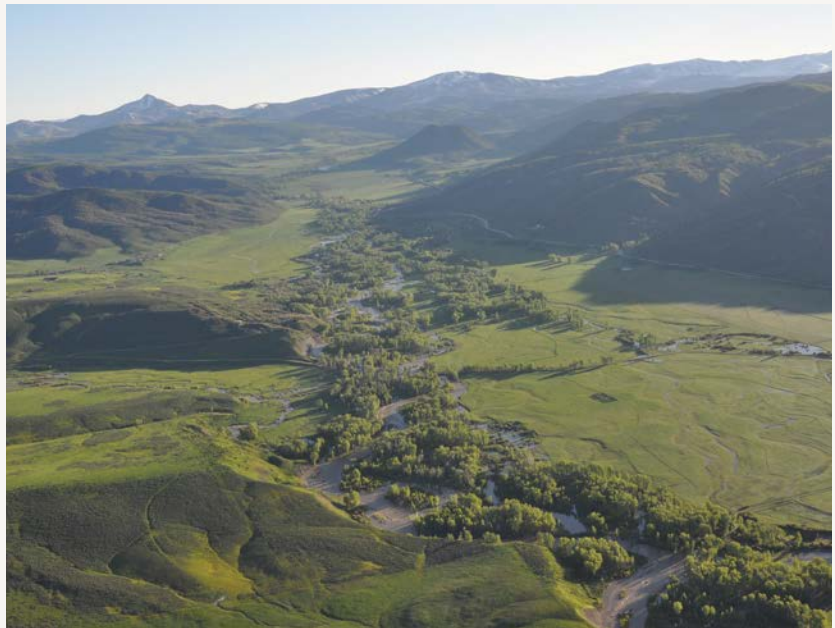
Figure 22. Elk River valley at flood stage in 2011. Courtesy of Andy Rossi.

Many avulsions have been observed on the Elk River between Clark and the confluence with the Yampa River. Local hydrologists surmise that these avulsions take place because the original channel begins to fill with excessive sediment. Gravel push-up dams are commonly constructed by river users to get water into their headgates. Other channel modifications to create fish habitat and to stabilize stream banks occur as well. Concerns are mounting that frequent river entry with heavy equipment, streambank modification, and lack of coordination between design teams and property owners have and will continue to lead to more avulsions and added bedload into the system.

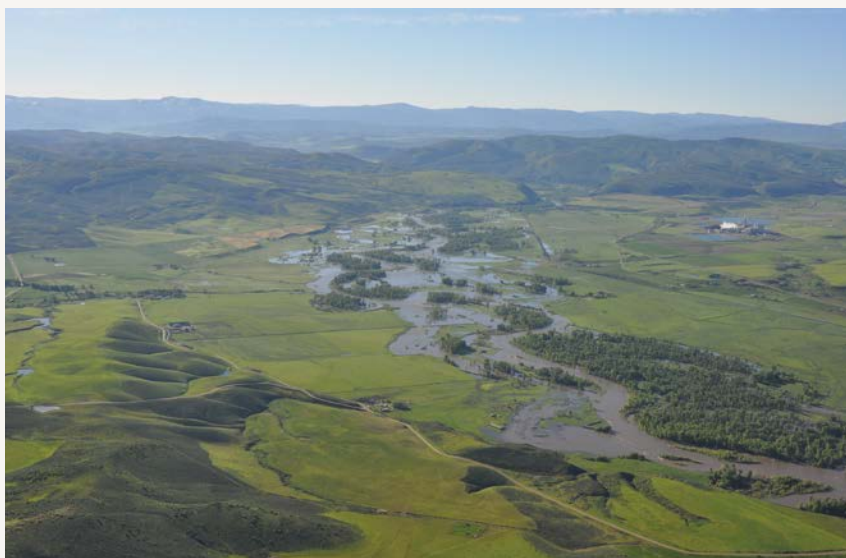
Figure 24. The Middle Yampa River valley at floodstage. Courtesy of Andy Rossi

Water in the Middle Yampa River subbasin has many uses: livestock, agriculture, power generation, coal and gravel mining, municipal supply and recreation (Figure 24). Wells and springs are used for rural residential water supplies, while community water and wastewater facilities exist in some rural home owners associations. Modern on-site wastewater treatment is used to treat sewage where wastewater facilities do not exist. The Town of Hayden pumps water out of the Yampa River for its municipal water supply. The town's wastewater facility discharges into the Yampa River. Milner, a community east of Hayden, uses on-site wells for municipal water but has a community wastewater treatment system which discharges into the Yampa River.

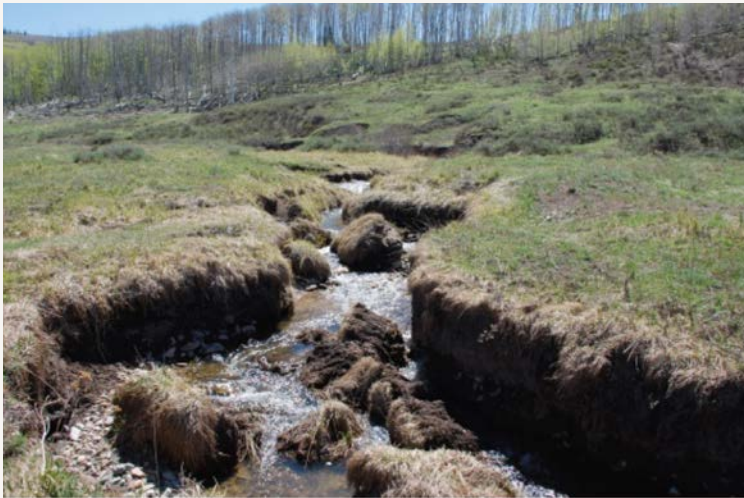
Figure 27. Incised channel in Armstrong Creek.
Courtesy of the U.S. Forest Service.

Water quality in the Elkhead Creek subbasin is relatively good. However, it has been observed that high sediment loads in the upper basin impact the Elkhead Creek system, including Elkhead Reservoir and various agricultural diversions. Lack of riparian vegetation and incised channels in the upper basin have resulted in excessive streambank erosion (Figure 27). Poor upland conditions, including extensive bare ground and noxious weeds, create minimal effective groundcover and contribute to increased erosion. This results in wide, shallow, and exposed channels which are more susceptible to heating (Figure 28). High temperatures make streams less favorable to cold water aquatic life including Colorado River cutthroat trout.
